# MOTION AMPLIFICATION FOR STRUCTURAL FAULT DIAGNOSIS

Excessive vibration was detected at the motor drive end of a membrane blower. To pinpoint the root cause, AVT Reliability® proposed a Motion Amplification™ survey to visualise the asset's dynamic behaviour and support root cause analysis.

EQUIPMENT: Membrane air blower

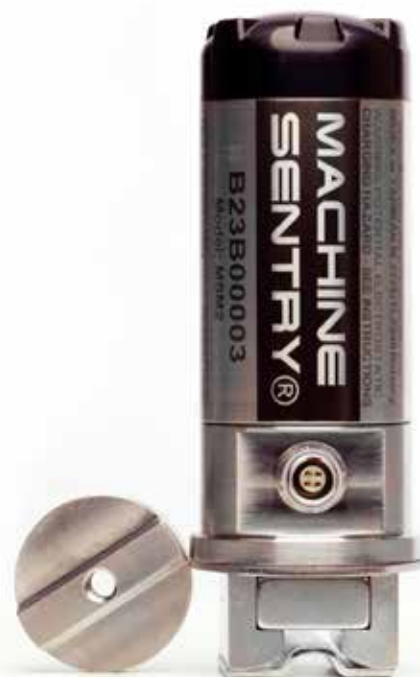
Initial vibration analysis showed high amplitude across all three planes, with a notable imbalance between the drive end (DE) and non-drive end (NDE), particularly in the horizontal and vertical planes. Spectral data revealed a dominant peak at 1X running speed (50Hz), indicative of a potential structural resonance or lack of mechanical support.

Using Motion Amplification™, AVT captured high-speed video footage to amplify and visualise movement. With a 50mm lens, motion analysis revealed a fractured weld on the support structure at the motor drive end. The root cause was confirmed to be a compromised structural weld, reducing system integrity and amplifying vibration levels. A full report was issued to site with recommendations.

- Conduct NDT (non-destructive testing) on all structural welds in the motor support frame
- Remove and re-weld all defective joints
- Perform a realignment between the motor and gearbox after weld repairs

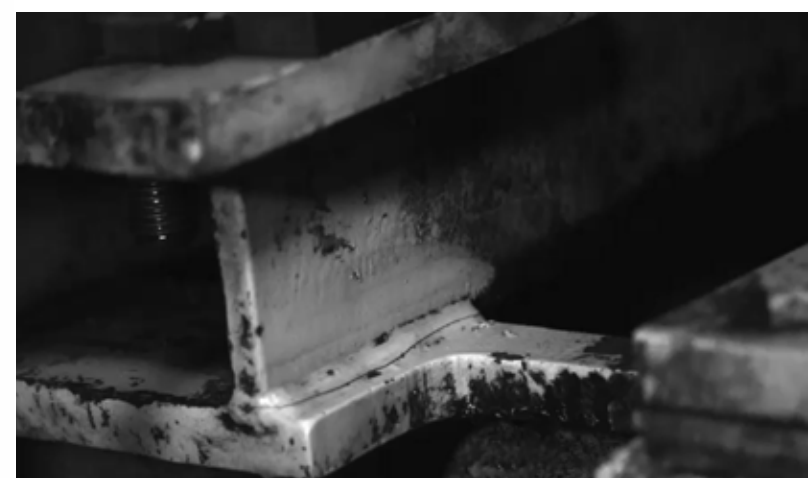
If left unresolved, the cracked weld could have led to structural failure, resulting in asset damage, costly downtime, and potential health and safety risks due to uncontrolled vibration or misalignment.

However, we have advised that a follow-up survey be conducted after repairs to confirm vibration levels have returned to acceptable thresholds.
