# EARLY DETECTION OF FAN INSTABILITY IN MARINE ENGINE ROOM

| Equipment: | Forward Engine Room Fan |

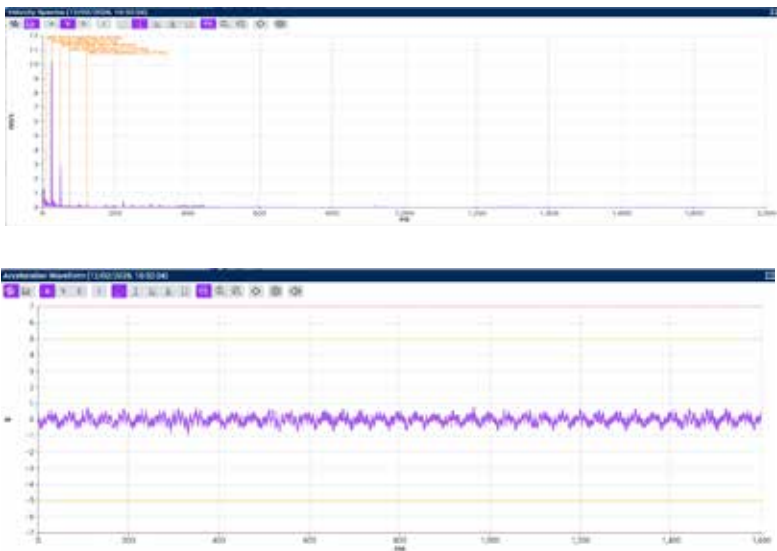
During inspection, AVT engineers observed a visible wobble in the fan during run-down, along with signs of wear on the anti-vibration mounts.

- Multiple harmonics of running speed
- Indicators of imbalance
- Signs of possible looseness at the motor/fan drive end

These findings suggested that the issue could be related to a combination of degraded mounting support, imbalance, or potential component looseness.

- Replace worn anti-vibration mounts
- Inspect the fan assembly for looseness or mechanical damage
- Check the motor drive-end bearing for play
- Clean impeller blades to remove any build-up
- Dynamically balance the fan if no structural defects are identified
