STOCKAGE CLINKER –  
TRANSPORTEUR AUMUND

THE PROBLEM

OUR FINDINGS

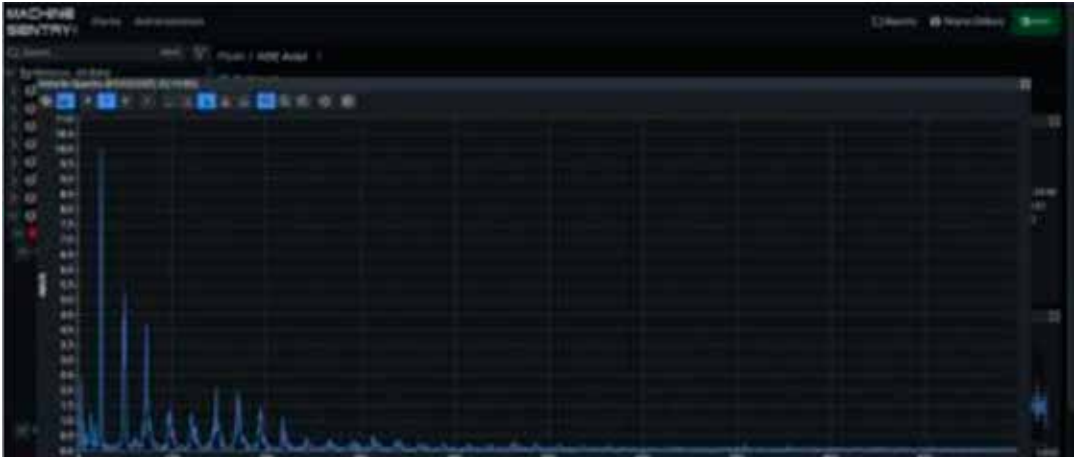
Fig. 1

Remote Vibration Monitoring utilising MSF vibration sensors are in use on the asset, which is an Electric Motor driving a Gearbox, analysis of the motor data revealed an increase a peak at 3x RPM indicating an alignment issue to the RDC Team.

The velocity spectra and trend had started to show an increase in levels in December 2024 and spectral data gave the RDC team cause for concern.

In figure 1 we see the velocity spectra before the action was conducted to realign the coupling, Y axis range is set to 12 mm/sec. Figure 2 we see the acceleration spectra after the motor was replaced, Y axis range is set to 2.2 mm/sec.

The customer decided to install a new motor and coupling.

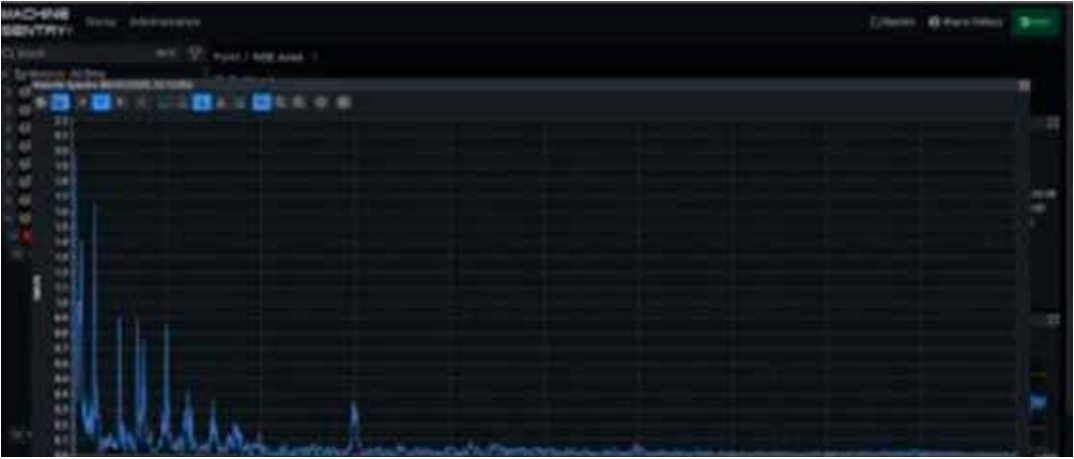
Fig. 2

The new motor and coupling were fitted during a routine shutdown. Since the new motor and coupling were installed, the monitoring has returned to monthly. vibration levels then reduced to satisfactory levels.
