## REMOTE MONITORING IDENTIFIES STRUCTURAL OR COUPLING WEAR ON CRITICAL COAL MILL FAN

AVT Reliability® provides condition-based maintenance support to this cement production site through daily remote vibration monitoring. Using Machine Sentry® fixed sensors, AVT's Remote Diagnostic Centre (RDC) identified early signs of structural looseness on a critical bag house exhaust fan.

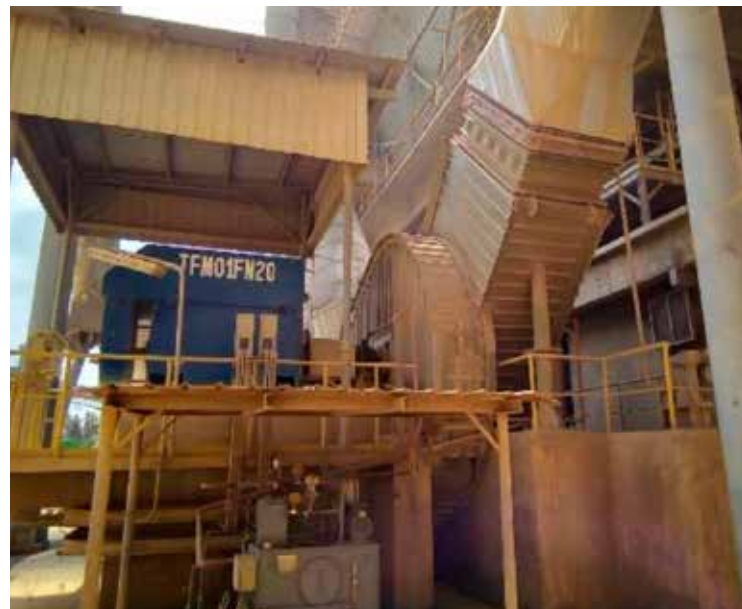
By March 2025, the velocity spectra showed signs consistent with looseness either in the support structure or the coupling. These elevated readings were cause for concern due to the asset's critical nature.

Fig 1: Velocity spectra before action – Y-axis range 9.0 mm/s

An action note was raised in Machine Sentry® and the customer was advised to inspect the coupling and structural supports for wear or looseness at the next available shutdown.

During a scheduled routine shutdown, the customer replaced the coupling.

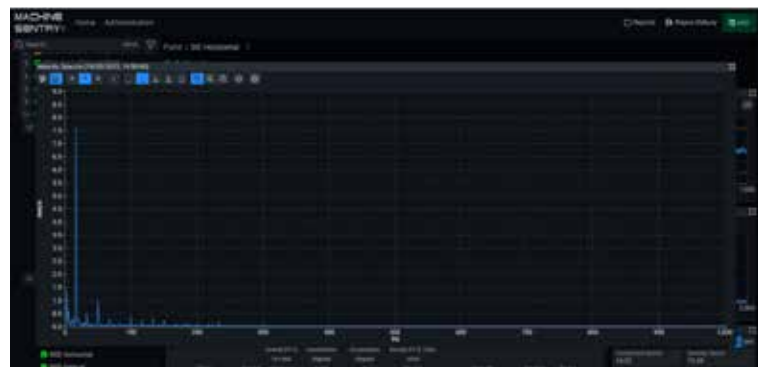
Post-repair vibration data confirmed that the velocity levels had returned to satisfactory thresholds, indicating successful resolution of the looseness issue.

Fig 2: Velocity spectra after coupling replacement – Y-axis range 1.2 mm/s

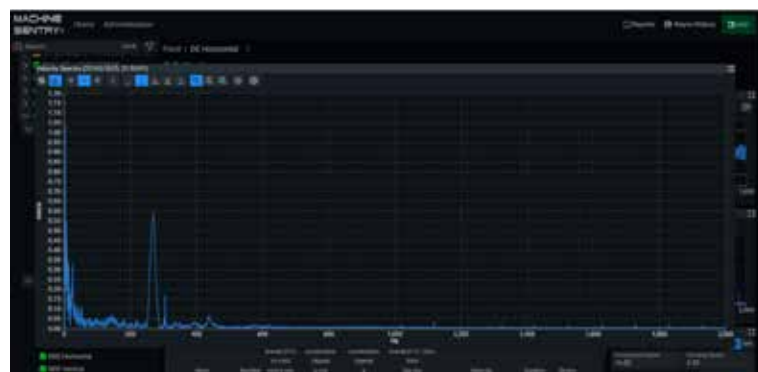
Fig 3: Comparative view – before and after repair spectra
