## RELIABILITY SUCCESS STORIES

*Best practice condition based maintenance in action*

Working to achieve a more reliable and predictable plant operation via condition-based maintenance repairs, lubrication practises and ultrasonic inspections, supported by the Machine Sentry® platform.

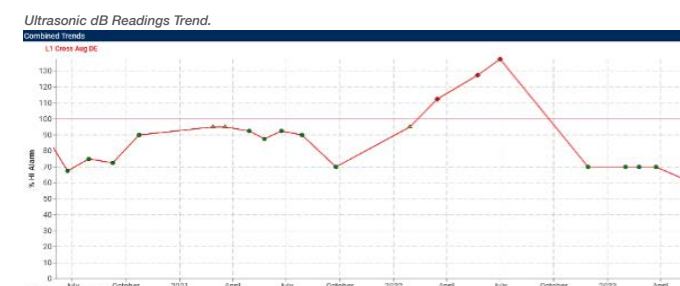
The follow up vibration data & Ultrasonic readings showed the overhaul was successful in reducing both acceleration levels & overall wear on the asset, reducing production downtime to a minimum.

Below and on the right, we can see the reduced values in the spectra and TWF from the motor and gearbox.

Vibration data collected from the Cooker Gearbox after repairs showed a significant reduction in vibration and dB levels. Using alarm levels in the AVT system set according to ISO 10816 (Vibration Severity Standards) we can see that all readings have changed from “Unacceptable” to “Good” due to the completed repairs.
