# PROVIDING CONFIDENCE IN LNG PIPEWORK INTEGRITY DURING CRITICAL PROCESS CHANGES

Real-time displacement monitoring verified that pipework movement remained within acceptable limits during a temperature change programme, supporting safe operation and maintenance planning.

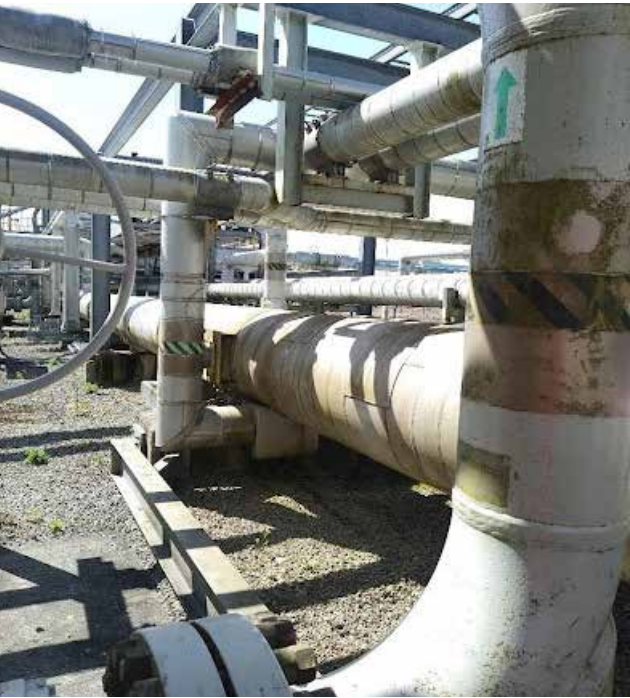
AVT Reliability's Asset Integrity Division installed displacement sensors at four key locations across the LNG Header and High-Pressure Drain Lines.

The sensors were mounted directly onto the pipe support feet and sliding support bases using a combination of magnetic fixtures and spacers. Each sensor was connected to an HBM QuantumX multi-channel data acquisition system via extension cabling, allowing continuous monitoring throughout the maintenance activity.
