# OIL ANALYSIS IDENTIFIES HIDDEN GEARBOX DAMAGE BEFORE CRITICAL FAILURE

Routine lubrication and oil analysis uncovered severe internal gearbox wear on a production-critical cooker mixer, enabling planned maintenance and avoiding more than £35,000 in potential costs.

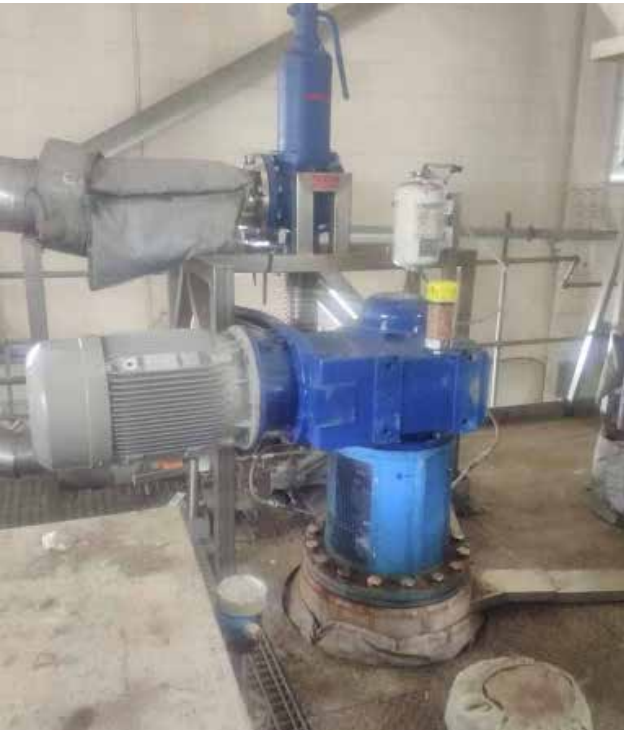
Recent reports identified increasing levels of iron wear particles, indicating abnormal internal wear. Following further investigation and inspection, several gearbox teeth were found to be chipped, heavily worn or broken.

The likely root cause was excessive movement caused by a damaged non-drive-end footstep bearing within the vessel, leading to abnormal loading and gear impact. Importantly, routine vibration analysis showed no significant abnormalities, demonstrating the value of oil analysis as an additional condition monitoring technique.

The findings were communicated to site management, allowing corrective action to be planned before the gearbox reached a critical failure condition. Following inspection, the gearbox was removed from service and replaced, with the damaged unit sent for refurbishment and further investigation.

To address the suspected root cause, the non-drive-end footstep bearing was added to the scope of the site's upcoming summer shutdown, where it will be inspected and repaired or replaced as required.
