# EARLY DETECTION OF FAN INSTABILITY IN MARINE ENGINE ROOM

| Equipment: | Forward Engine Room Fan |

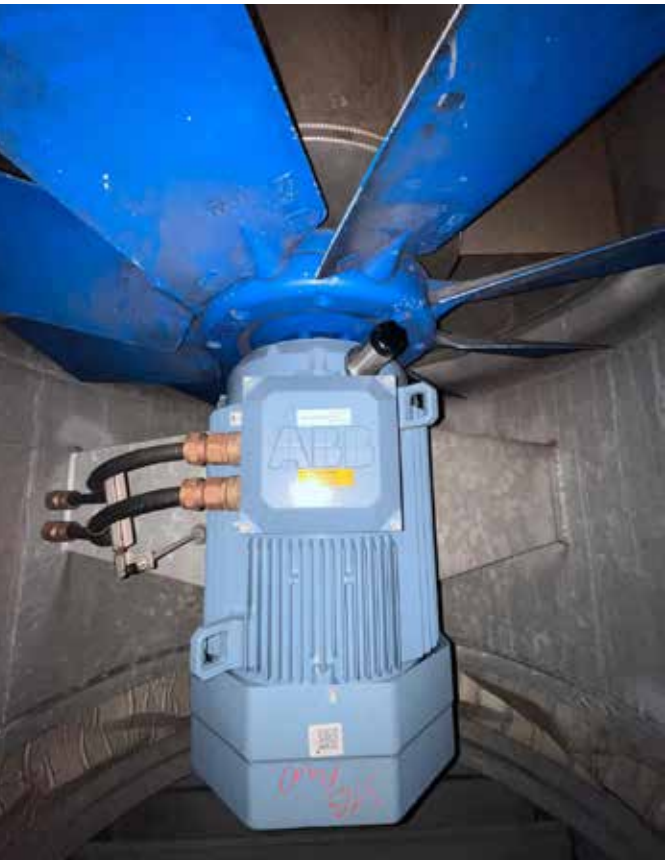
During inspection, AVT engineers observed a visible wobble in the fan during run-down, along with signs of wear on the anti-vibration mounts.

Vibration analysis revealed:

- Multiple harmonics of running speed
- Indicators of imbalance
- Signs of possible looseness at the motor/fan drive end

These findings suggested that the issue could be related to a combination of degraded mounting support, imbalance, or potential component looseness.

- Replace worn anti-vibration mounts
- Inspect the fan assembly for looseness or mechanical damage
- Check the motor drive-end bearing for play
- Clean impeller blades to remove any build-up
- Dynamically balance the fan if no structural defects are identified
